THE RESTORATION OF THE KRISHNA TEMPLE

PATAN - NEPAL

2015 - 2018

NEETA DAS

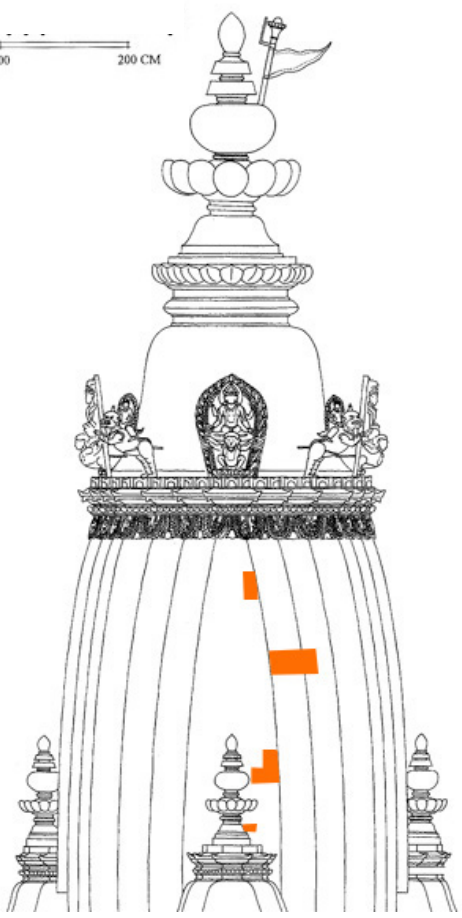
Mapping 3: East-mapping of new stone blocks, drawings by KVPT, modified by Katharina Fuchs.

Several original stone blocks were in rather bad condition showing cracks, fractures, delamination and detached scales. With regard to the risk, that they may fall down and the unknown date of re-access to the roof area in the future, it was decided to replace these heavily damaged blocks in order to avoid harm to humans by falling parts (see mappings 2-5). The local stone mason was assigned to prepare tight-fitting stone indents (figs.13 and 14). These were just fixed with a few spots of epoxy resin (Akepox 2010, Akemi), further reinforcement (e.g. pins, clamps) was not considered necessary to keep them in place (fig.15). After hardening of the resin, the joints around the new stone blocks were repointed.

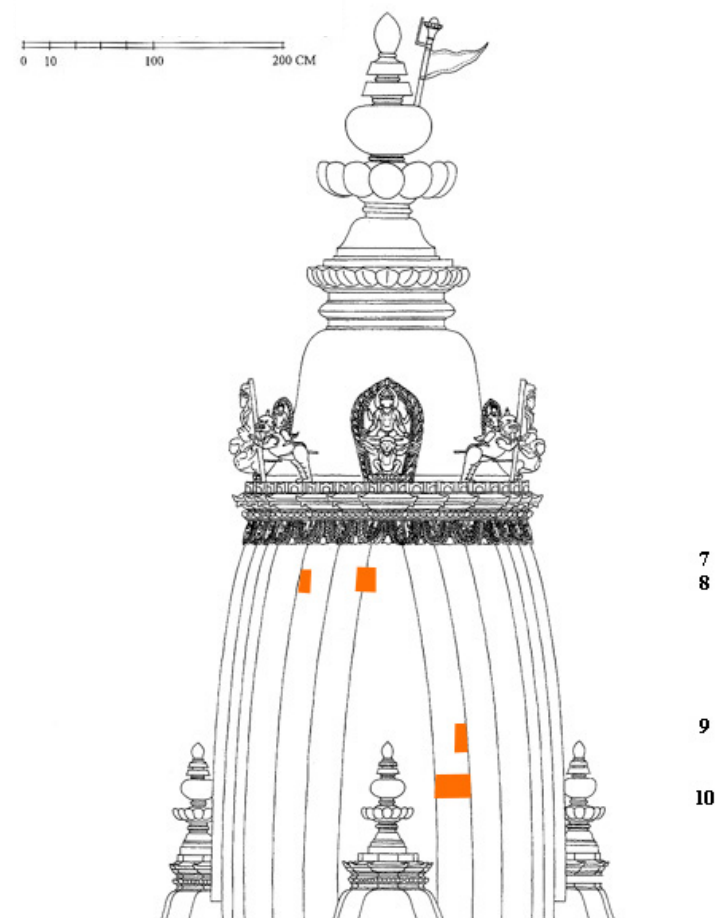
Mapping 4: South -mapping of new stone blocks, drawings by KVPT, modified by Katharina Fuchs.

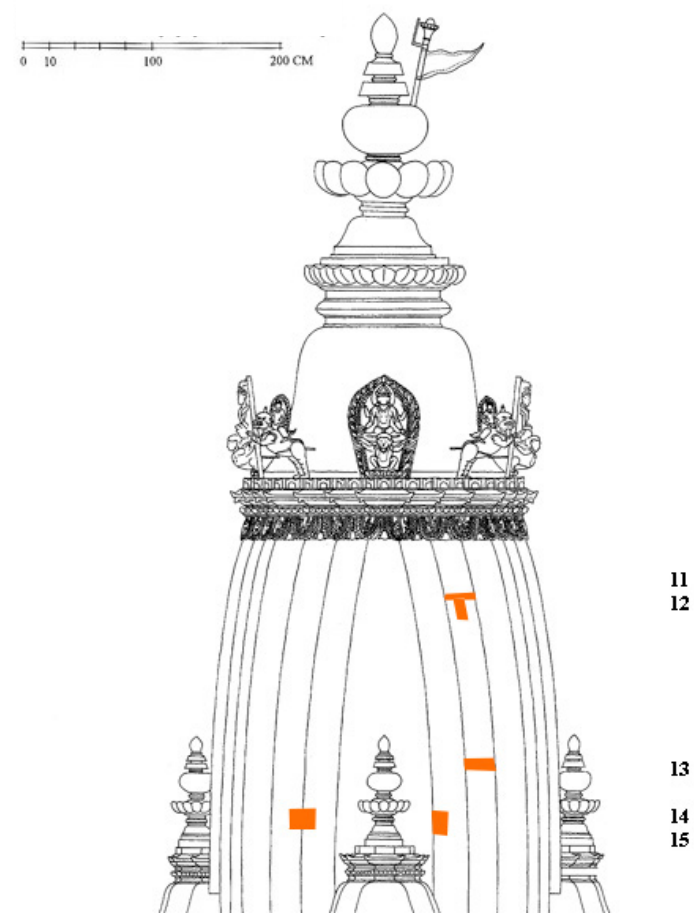
Mapping 5: West-mapping of new stone blocks, drawings by KVPT, modified by Katharina Fuchs.

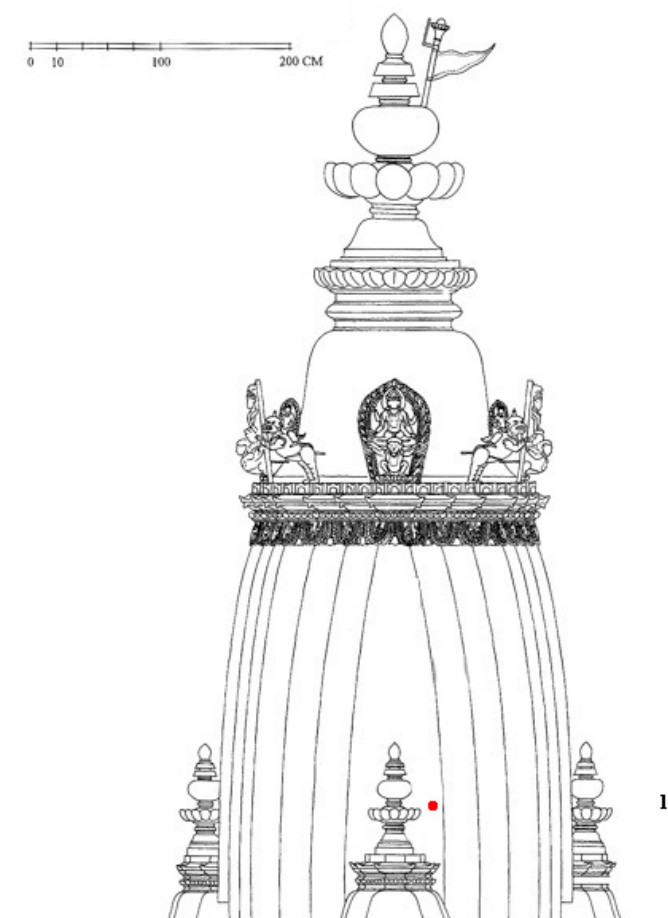
Mapping 6: East -Mapping of the found iron clamp, drawing by KVPT, modified by Katharina Fuchs.

Corroded iron clamps, which were detected (see mappings 6 and 7) during working process, were treated accordingly. Measures included mechanical removal of corrosion and application of a protective layer of lead oxide (red lead, minium) to inhibit future corrosion (figs.16-19). Subsequently, mortar was applied above the clamps. The complete removal of the iron clamps was not possible without damaging the original stone substance.

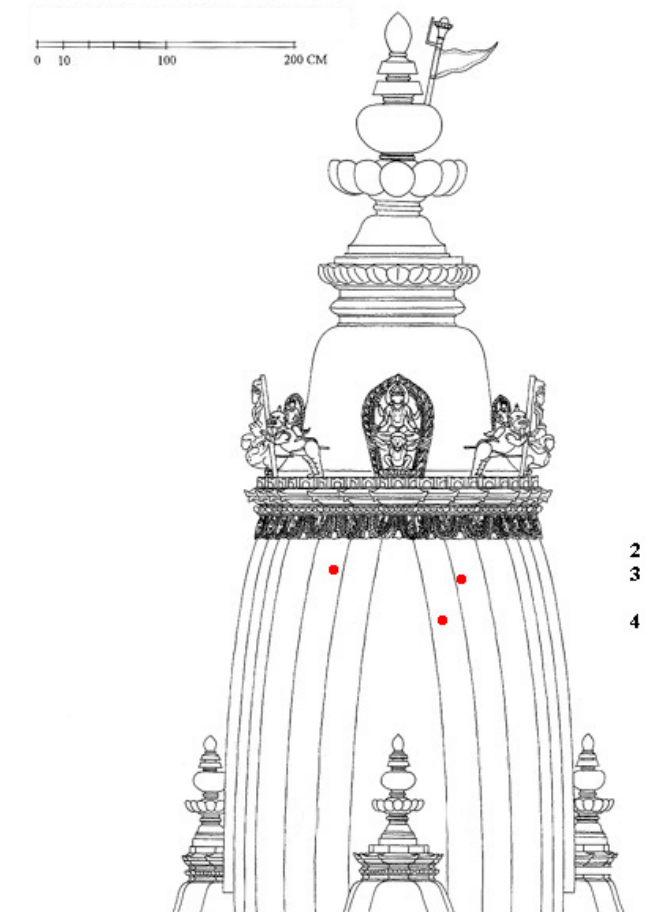
Mapping 7: West-Mapping of the found iron clamp, drawing by KVPT, modified by Katharina Fuchs.

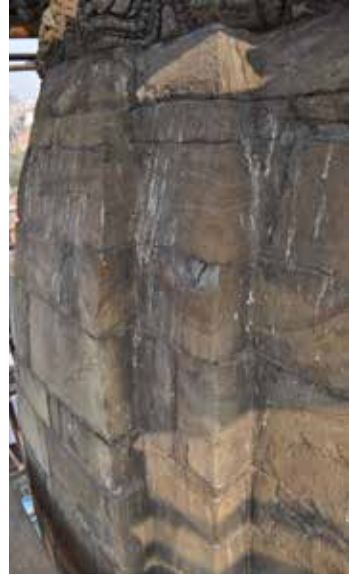
Left Top
Fig.29: Condition before conservation.

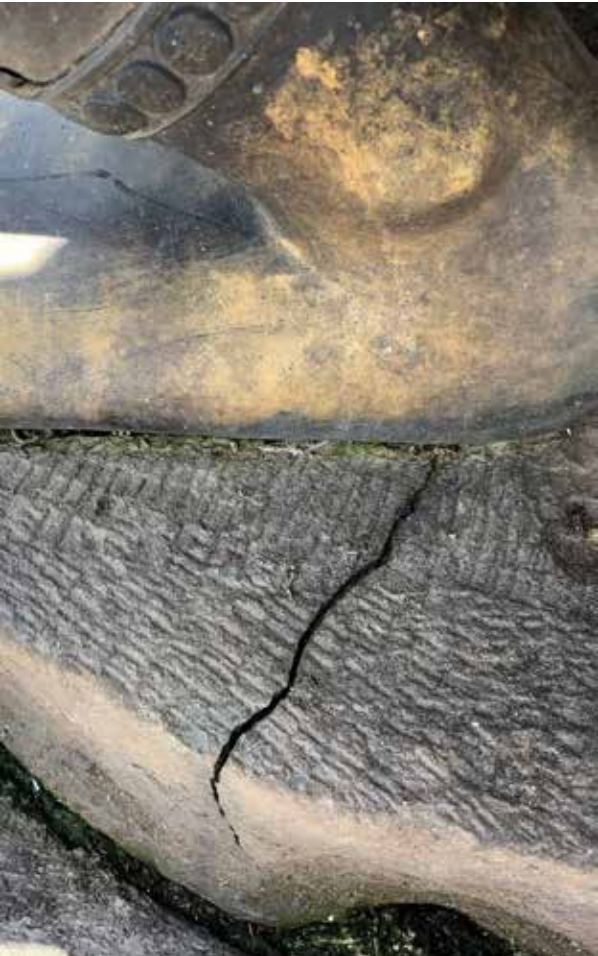
Left
Fig.3: Open crack at the
plinth, visible microbiological
colonization

The crack at the plinth (figs. 3 and 4) was additionally pre-filled with pure natural hydraulic lime mixed with water to an injectable consistency before the joint mortar was applied.

In order to avoid water infiltration in the upper part of the pillar, open joints and small cracks were pointed and closed with a mortar based on natural hydraulic lime (NHL 3.5, LaFarge) and different sand.⁶ For wider cracks, sand with a slightly different grain size distribution was used for the pointing mortar.⁷

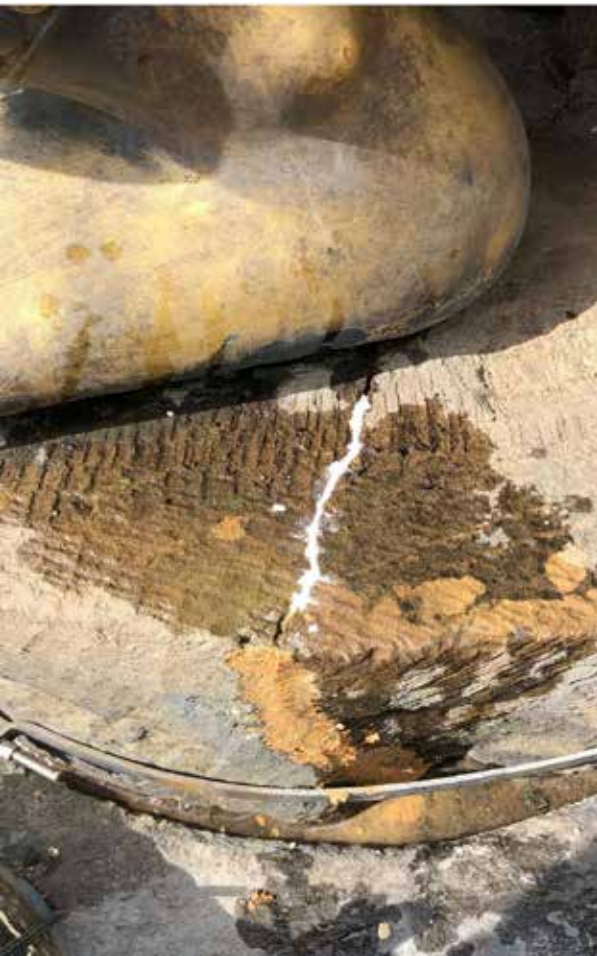
Right
Fig.4: Cleaned surfaces, crack with
filled injection grout at the plinth
of Garuda

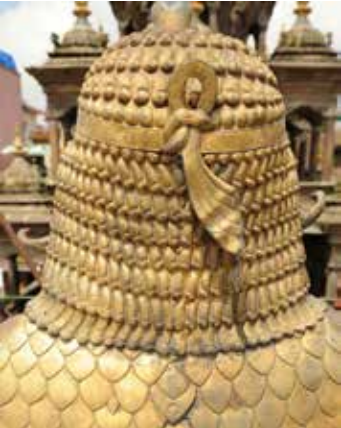
On the surfaces of the metal sculpture corrosion products were visible. Furthermore, the gilding has been reduced on some areas. One of the iron rings was already corroded due to direct exposure to weathering, the climatic conditions in Nepal (wet and dry periods) and the high pollution within the city.

Right Top
Fig.6: Detail of Garuda before
cleaning

The fire-gilded metal sculpture of Garuda was dry cleaned in a first step to remove loose deposits, dust and dirt. Then a wet cleaning with a tenside-solution and brushes was done (figs.6 and 7). Corrosion products were removed mechanically. Cracks and holes in the metal surface were closed with epoxy resin (Akepox 2010, Akemi) to avoid water infiltration. The corrosion on the metal rings was mechanically reduced with a fine wire brush.
